# Water Level and Flow Effects on Historic Resources Study Report

Lowell Hydroelectric Project (FERC No.  
2790)

November 1, 2021

Boott Hydropower, LLC  
Manchester, New Hampshire

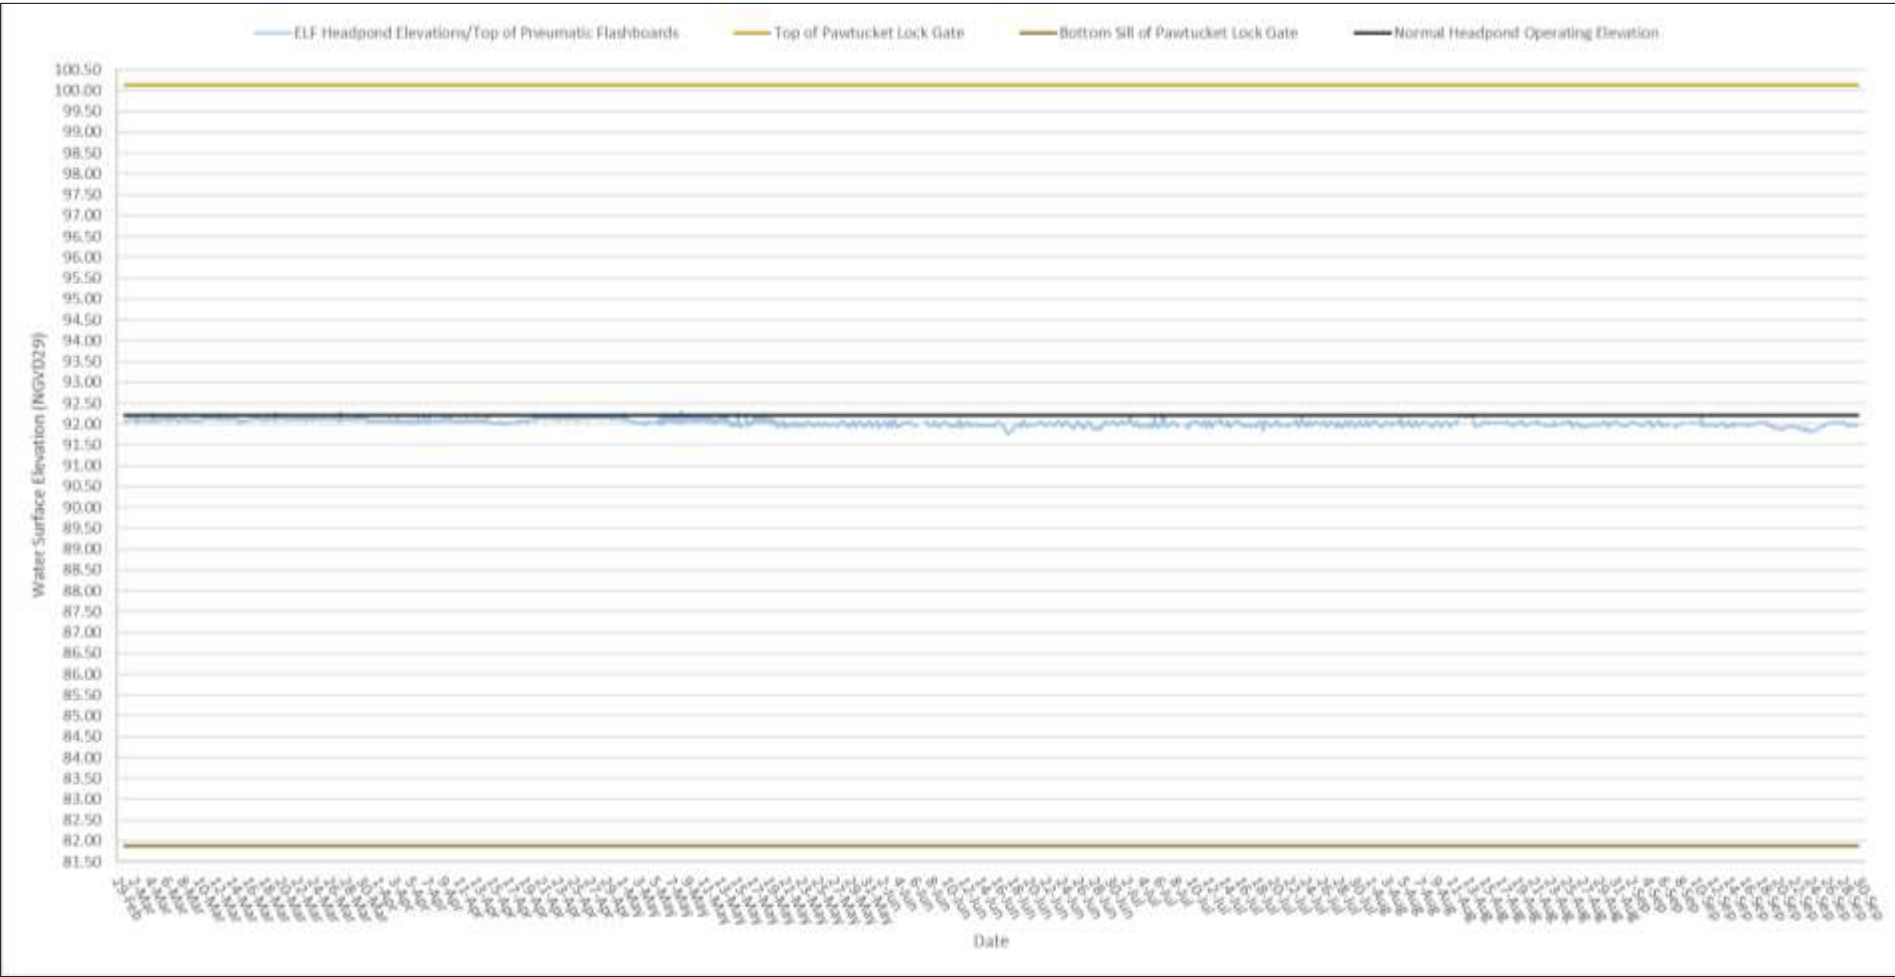
**Figure 5-2. Project Headpond Water Surface Elevation During 2020 Monitoring Period Relative to Top and Bottom Sills of the Northern Canal Lock Gate**

Figure 5-2 shows the estimated elevations of the top and bottom sill of the Pawtucket Gatehouse Lock Gate relative to the water level of the Project headpond.

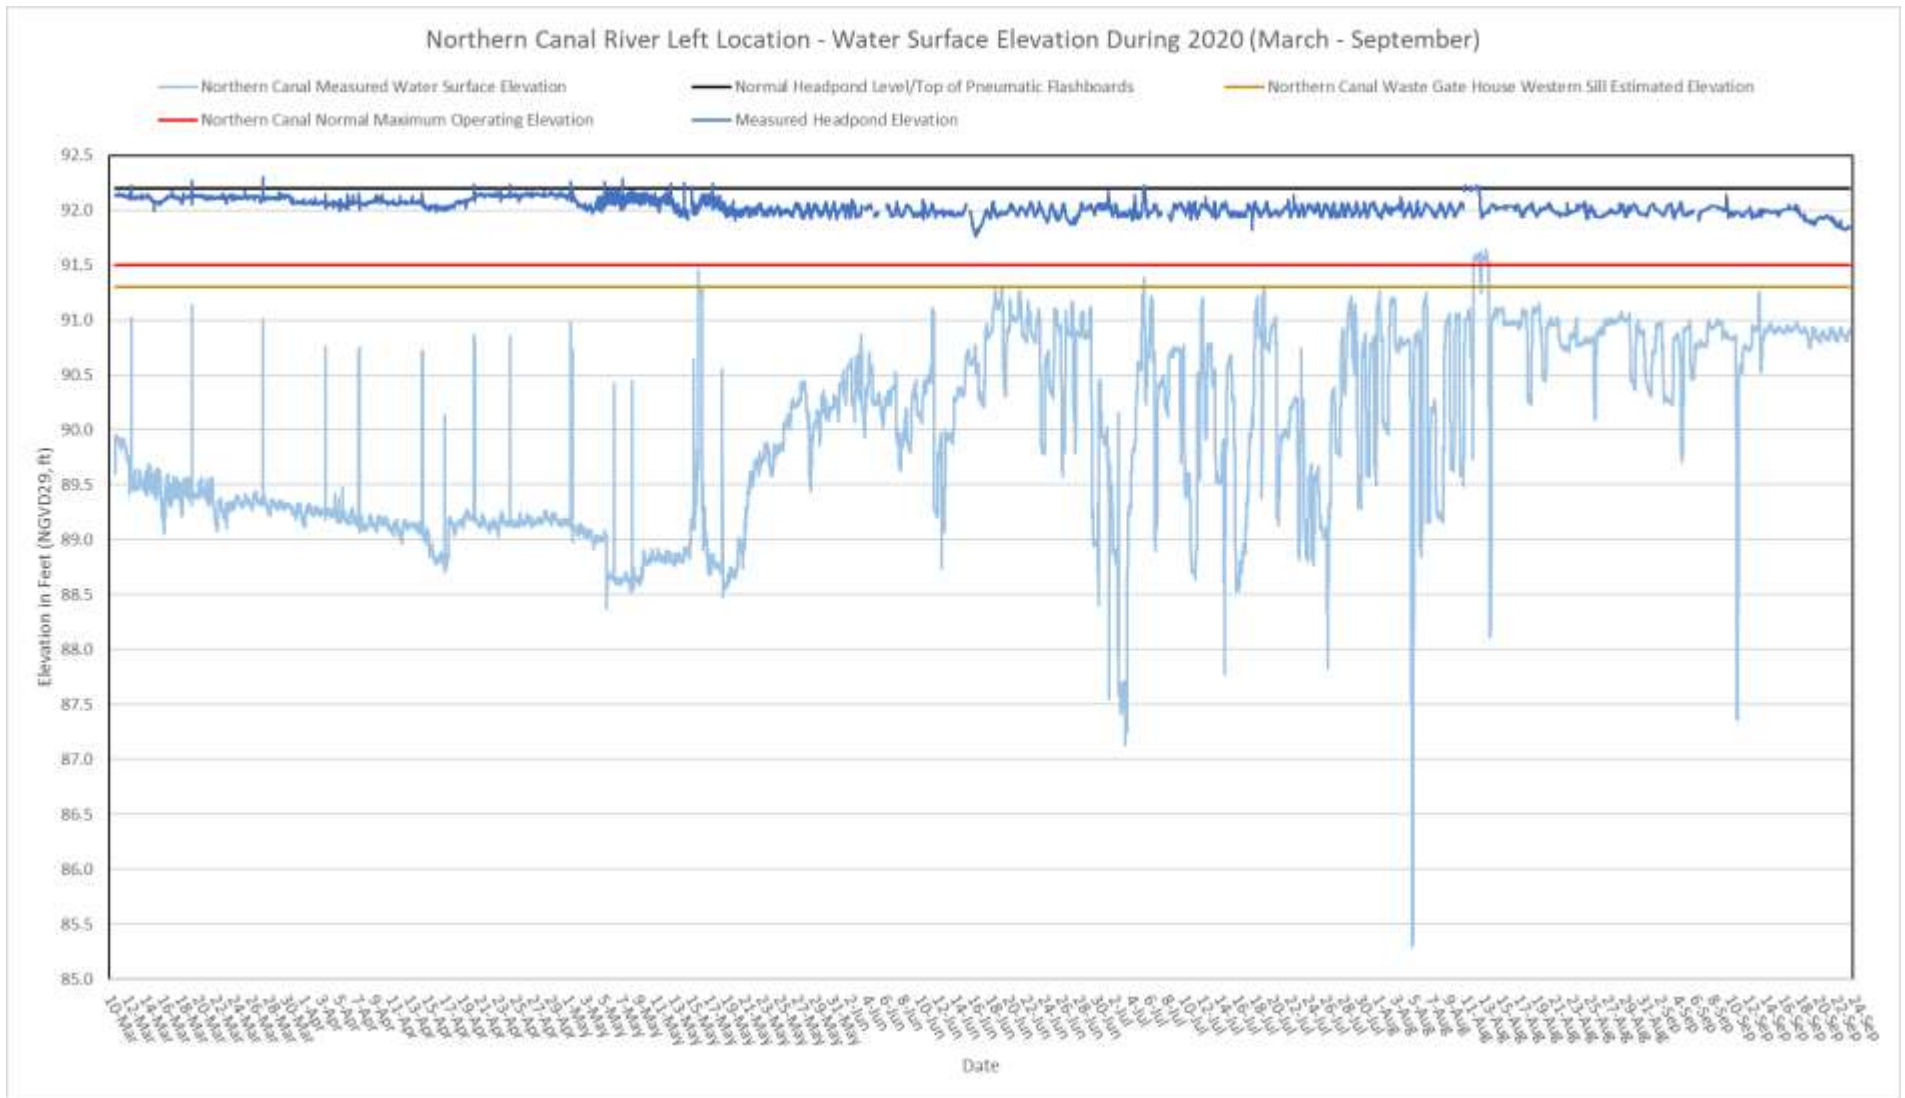
Figure 5-3. Northern Canal River Left Location - Water Surface Elevation During 2020 Monitoring Period

Water surface elevations within the Northern Canal collected during the study period ranged from a minimum of 85.30 ft to a maximum of 91.64 ft (Figure 5-3) with a range of 6.34 ft at the Northern Canal River Left (RL) location near the Emergency Surge Gate and from a minimum of 85.71 ft to a maximum of 92.14 ft (Figure 5-4) for a range of 6.43 ft at the Northern Canal River Right (RR) location, near the canal's mid-point between the Pawtucket Gatehouse and the E.L. Field powerhouse.

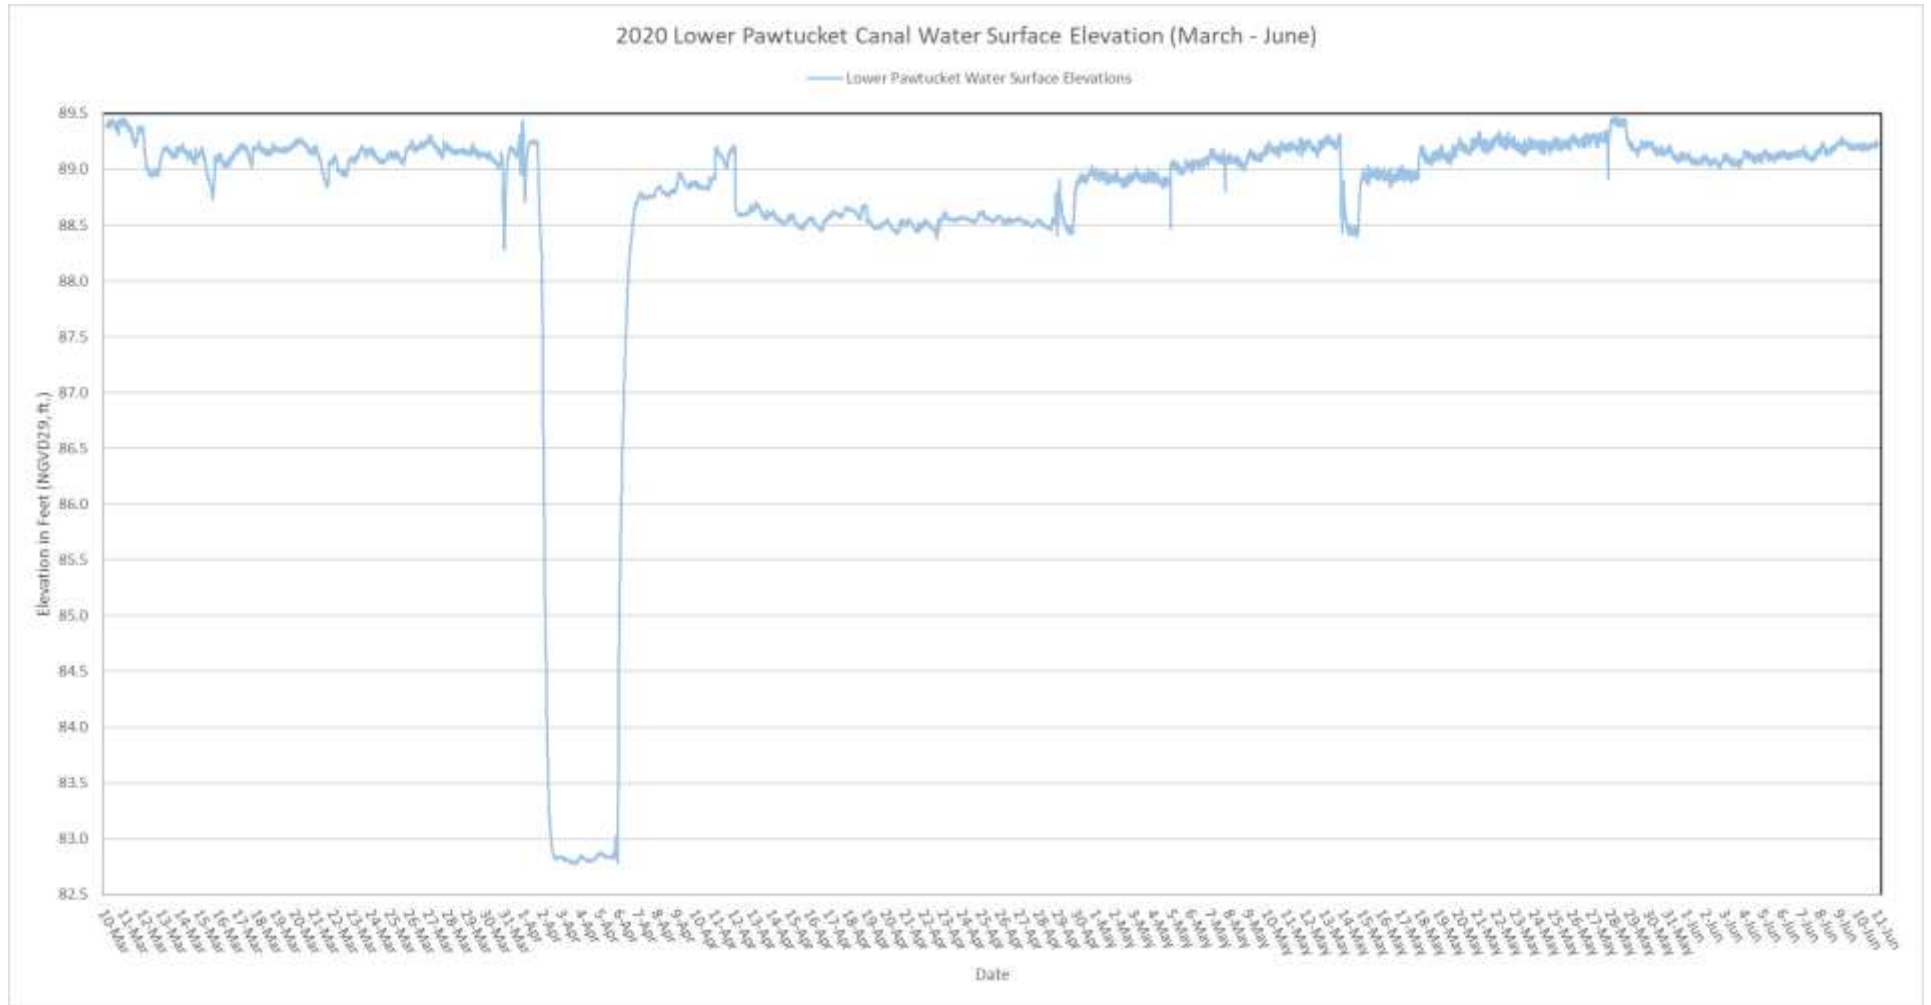
Figure 5-6. 2020 Lower Pawtucket Canal Water Surface Elevation (March 10 – June 11)

The Lower Pawtucket Canal was drawn down approximately 6.5 ft from April 2 through April 7, 2020 to facilitate bridge reconstruction in downtown Lowell, but generally remained between elevations 88.25 ft and 89.47 ft, a range of 1.22 ft during the remaining study period.

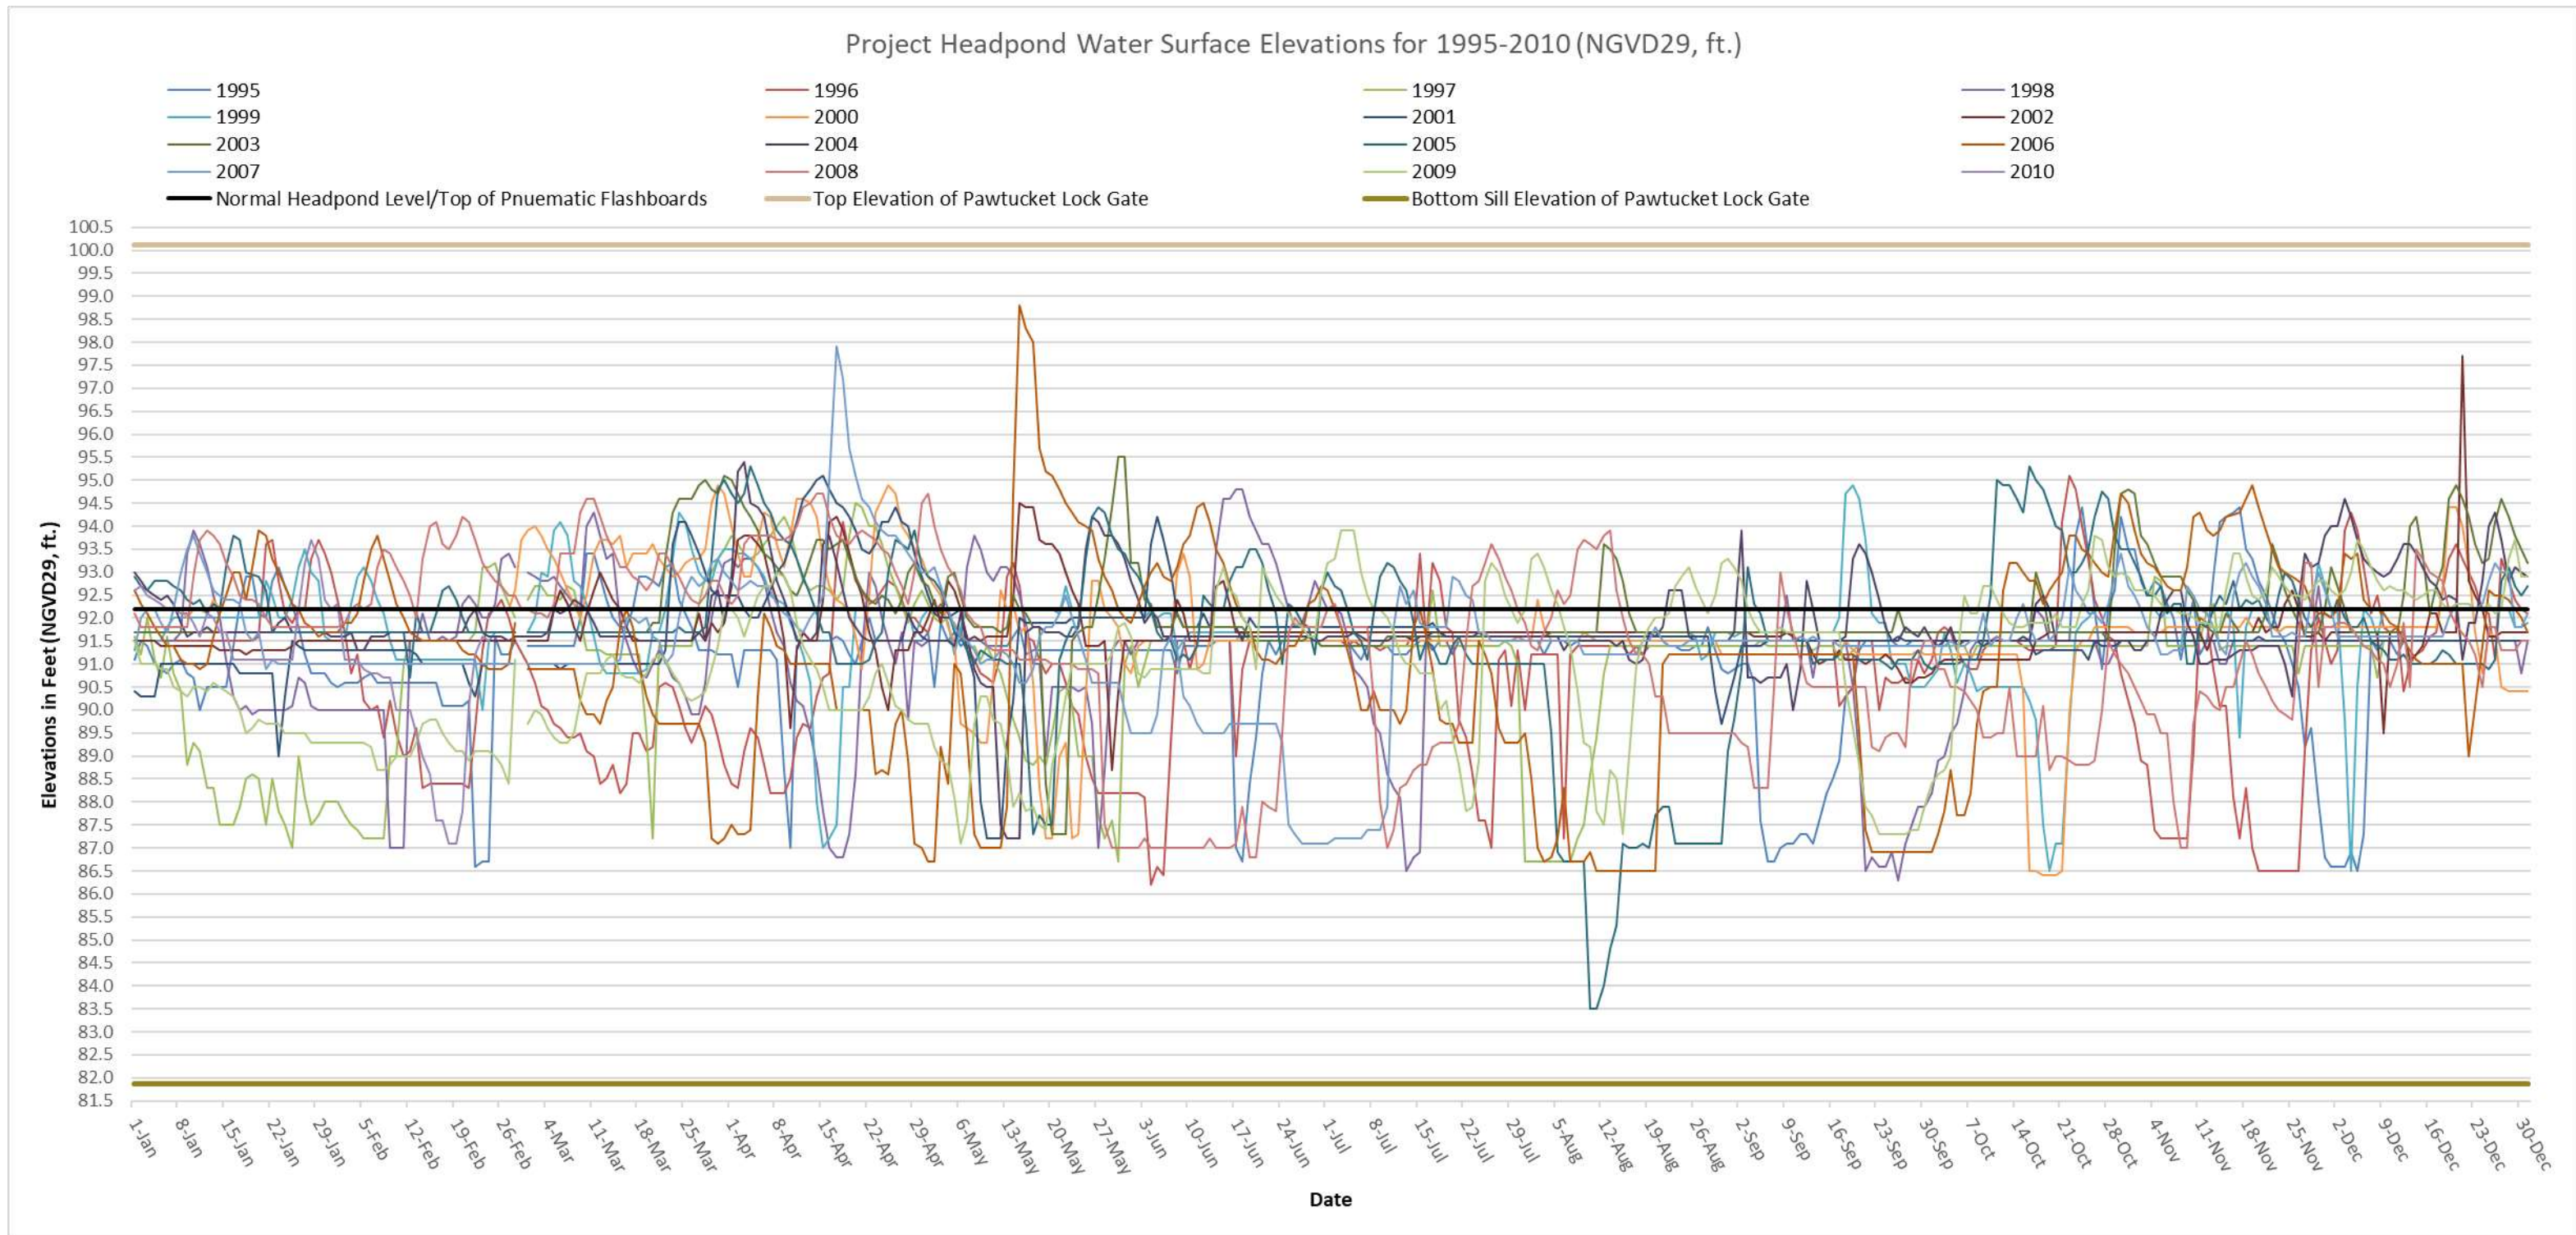
Figure 5-7. Merrimack River – Pawtucket Dam Headpond Elevations for Period of Record (1995-2010)<sup>4</sup>

Boott has reviewed the operational data for the Pawtucket Dam headpond elevations and the E.L. Field Powerhouse forebay elevations for the available period of record (January 1995 through December 2010 (Figure 5-7 and Figure 5-8). These data are from the period when 5-foot-high wooden flashboards were deployed on the spillway crest, prior to the construction of the present pneumatic crest gate system. The data demonstrate that with the wooden flashboards, headpond levels were highly variable, due in large part to the Licensee's inability to maintain normal pond level when the flashboards were partially damaged or failed. Repair and replacement of the failed flashboards required a 5-foot drawdown of the project impoundment, typically for 2 days, to enable safe working conditions on the dam crest. In contrast, the pneumatic crest gate system maintains a steady impoundment level by automatically adjusting the height of the crest gate panels in response to increasing flows (Figure 5-1 and Figure 5-2). As flows recede the crest gates are automatically raised, thereby eliminating any need for impoundment drawdowns for flashboard repairs. With the original flashboards in place, headpond elevations were driven by the type of water year (wet, normal, dry) and were much more variable, although typical for a riverine environment. Figure 5-7 shows that during most normal years the headpond is maintained at or near crest elevation for a large portion of the year. Exceptions occur during seasonal spring freshet (mid-March to mid-April), during the fall rainy season (mid-October to early December) and during the occasional anomalous event.

<sup>4</sup> Period of Record Data 1995-2010 was recorded with 5-foot high wooden flash boards in operation and prior to the installation of the automated pneumatic flashboards along the crest of the Pawtucket Dam.

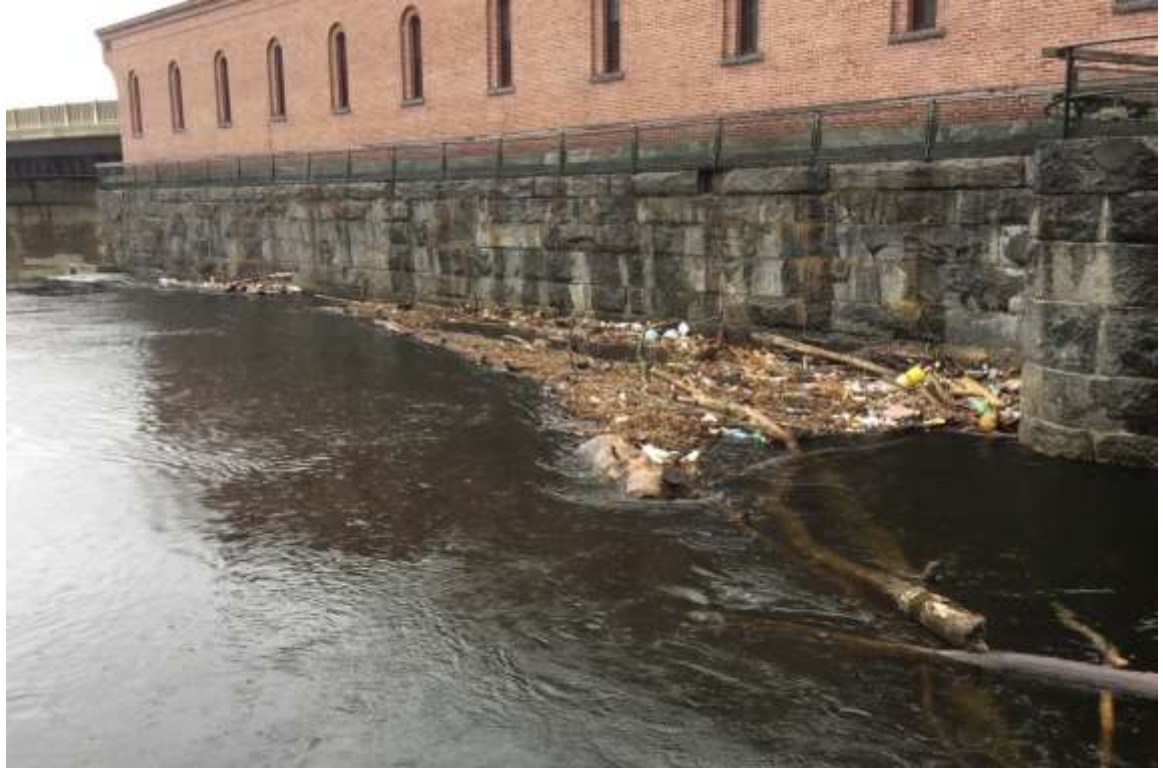
The concrete and masonry gatehouse show normal wear from exposure to the natural river conditions and Project water level fluctuation. Based on a review of existing documentation and consultation with the NPS, Boott did not identify potential Project-related effects on the gatehouse.

*Photo 5-1. Northern Canal Lock and Pawtucket Gatehouse.*

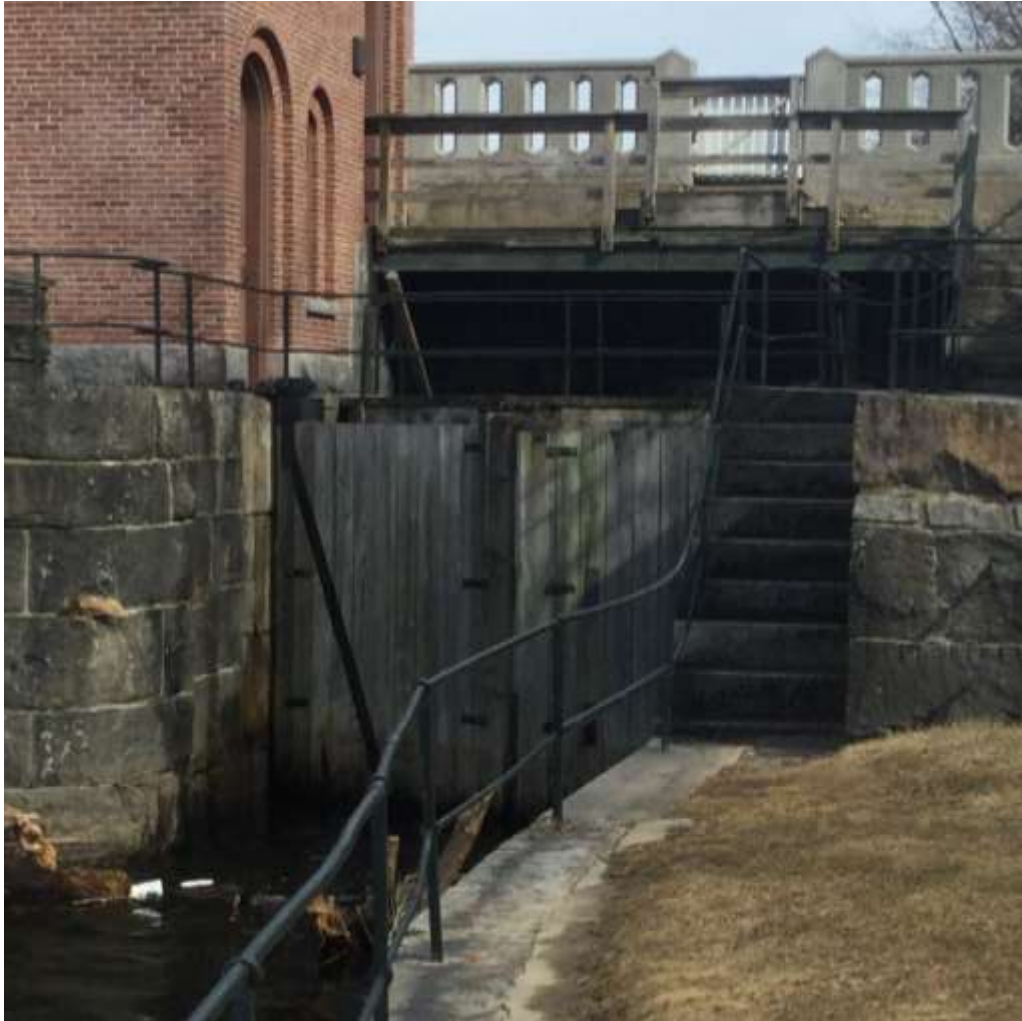
***Photo 5-2. Pawtucket Gatehouse at Northern Canal Gate entrance (prior to 2018 gate damage).***

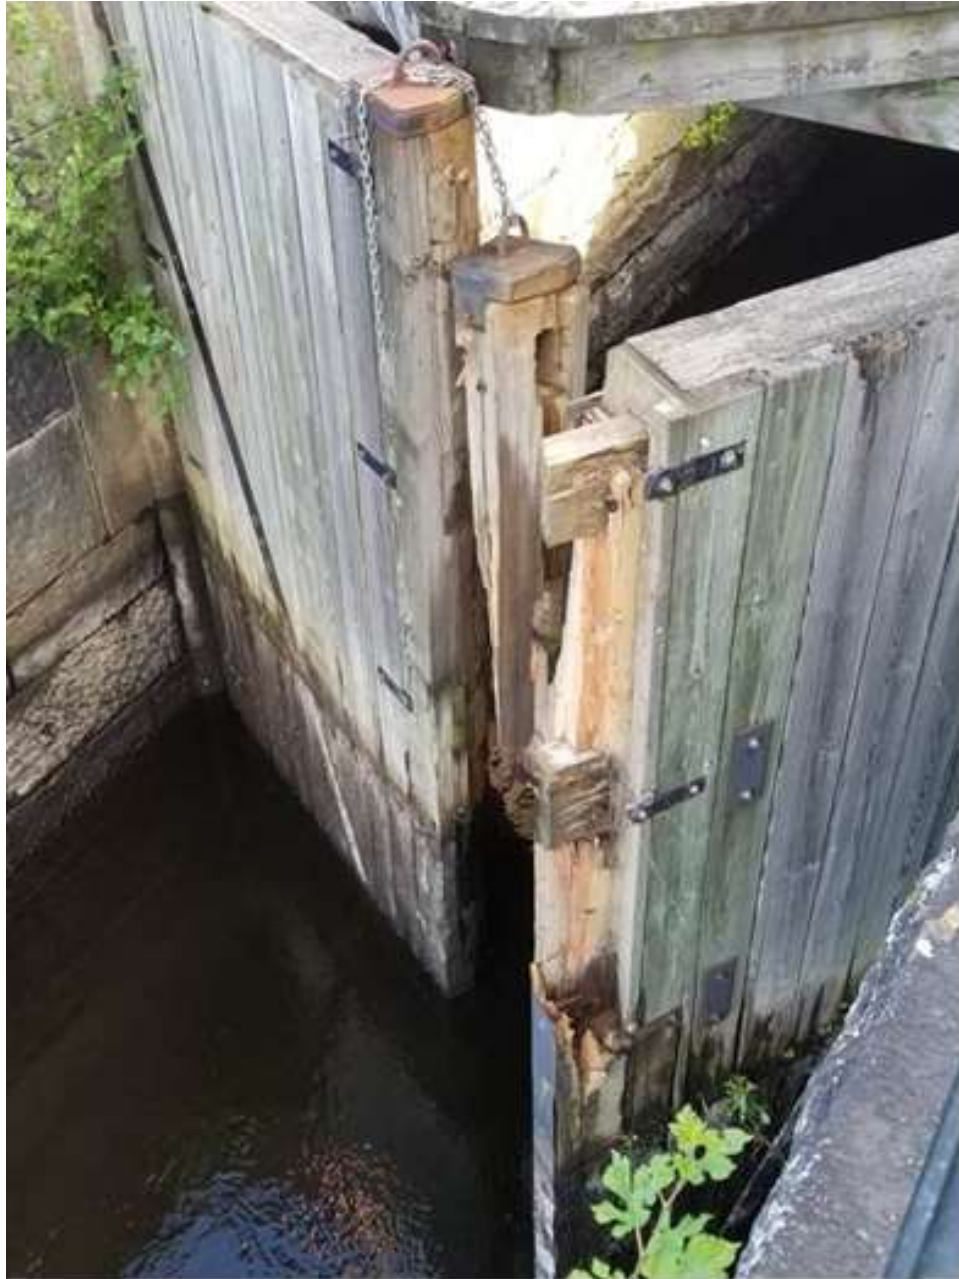
Potential Project-related effects have been documented at the Northern Canal lock structure. The lock structure is controlled by a set of timber miter gates, with one set of gates at the upstream entrance/exit and a second set at the downstream entrance/exit. The gates are subject to routine water level fluctuations (see Figure 5-1 through Figure 5-4) that can deteriorate wooden and metal elements. While the magnitude of fluctuation in the Project's headpond has been significantly reduced by the implementation of the pneumatic crest gates, the gates are subject to routine seasonal high flow events. Portions of the gates are also continuously submerged, which contributes to natural deterioration of wooden and metal elements over time. Photo 5-3 shows the normal water level that is maintained approximately midway on the gate height, and Photo 5-4 shows the deterioration of wood and metal on the removed gate normally below the water surface.

On August 26, 2018, the right (facing downstream) timber gate controlling the upstream entrance/exit to the Northern Canal lock was damaged. The damage to the gate was caused by an unusual back surge of water moving upstream through the Northern Canal,

caused by a water level transducer malfunction. Under normal operations, the existing surge gate would be automatically activated upon full shutdown of the E.L. Field units to discharge the resulting back-surge of flow into the bypass reach. In this instance, the surge gate did not open because the malfunctioning transducer at the Pawtucket Gatehouse caused the E.L. Field units to back down rapidly but did not cause them to trip off-line. As a result, the rapid unit backdown created a water-hammer effect that surged up the Northern Canal and into the miter gates. The gates had been previously chained together at their upper corner (See Photo 5-3), which prevented the gates from opening and releasing the surge as it moved upstream, and thus causing the right gate to break. Boott has recently removed the gate from service, and it is currently under repair.

Other factors which have likely contributed to the deterioration of the miter gates include, but are not limited to, high flows in the Merrimack River and natural deterioration of the submerged portions of the wooden gate structure, neither of which are attributable to Project operations.

*Photo 5-3. Damage to the Northern Canal Lock Timber Gate.*

While normal Project operations do not appear to be adversely affecting the Pawtucket Gatehouse Lock Structure beyond normal wear, at least one incident appears to have contributed to recorded damage to the upstream miter gate. The canal surge event that occurred in 2018 was caused by the malfunction of a water level transducer. The effect of the resulting surge was exacerbated by the practice of chaining the gates closed. This anomalous incident does not represent normal Project operations, and Boott is repairing the damage to the gate.

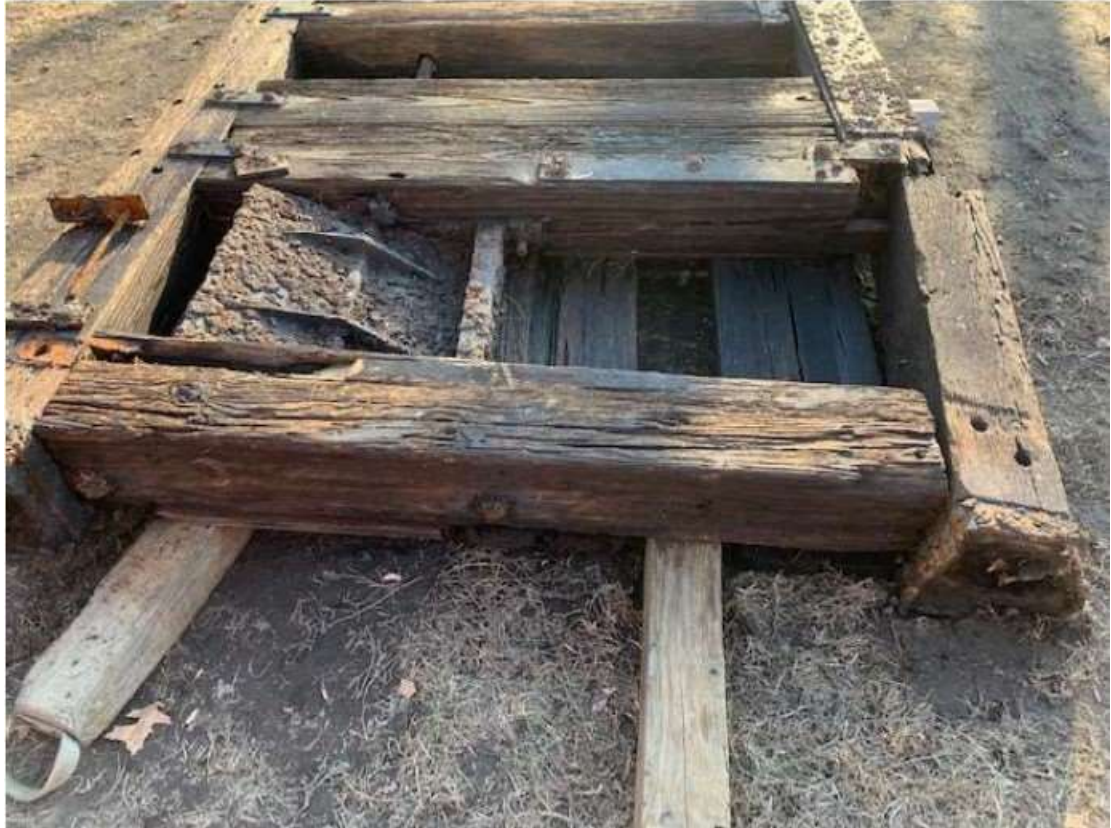
*Photo 5-4. Photo of wear of submerged portion of the Northern Canal Gate removed for repair.*

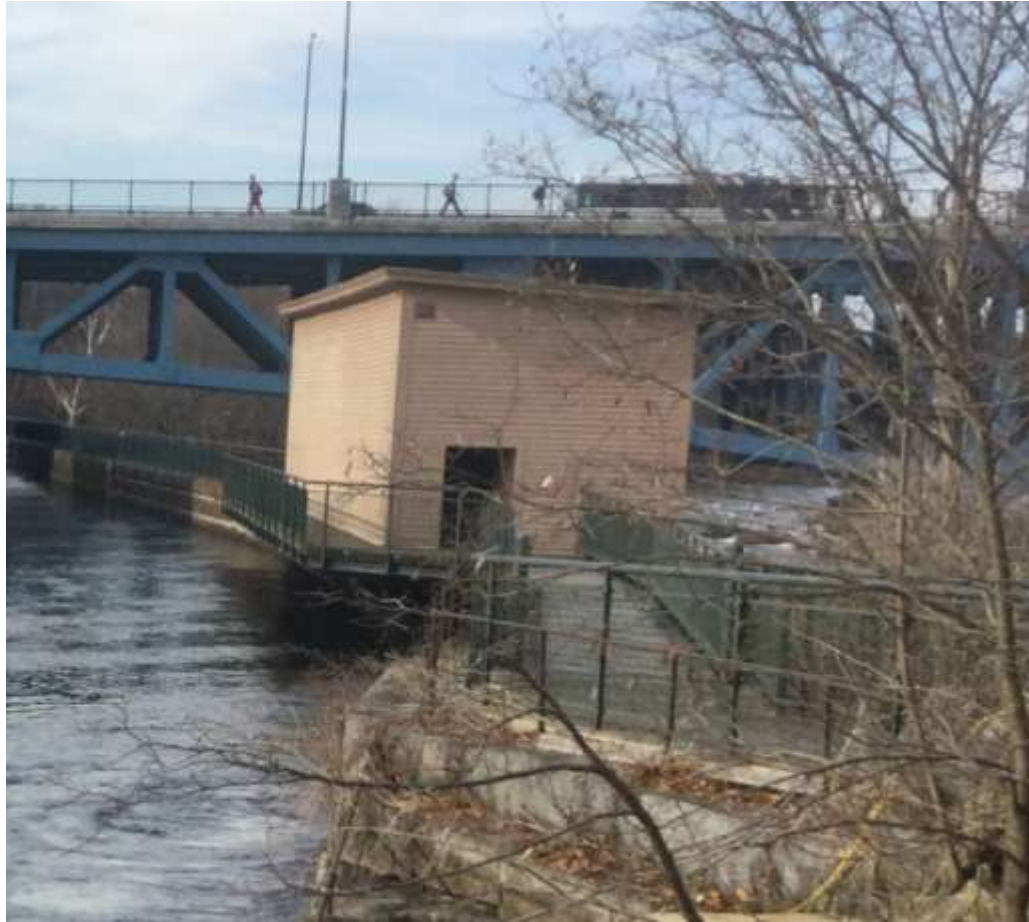
The Northern Canal Waste Gatehouse is a single-story, heavy-timber-framed building, built circa 1872 atop the Great River Wall which houses gate operators for four canal release gates (Photo 5-5). Based on consultation with the NPS, Boott identified potential Project-related effects on certain wooden structural elements of the Northern Canal Waste Gatehouse. The wooden sills of the gatehouse have experienced deterioration. Boott reviewed Northern Canal water level data recorded in 2020 to determine if Northern Canal water levels could be a contributing factor to the deterioration of the sill.

*Photo 5-5. Northern Canal Waste Gatehouse atop the Northern Canal.*

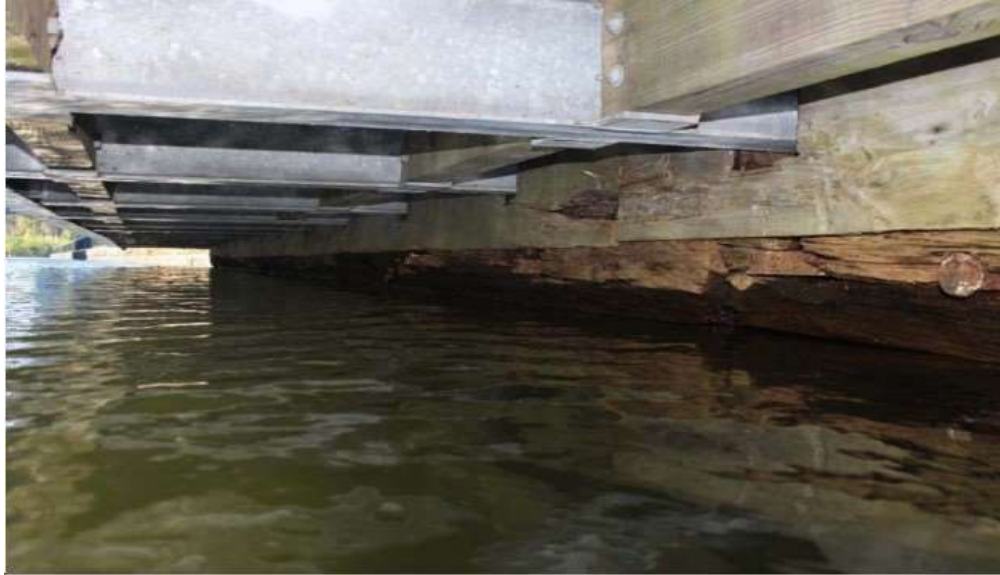
As shown in Figure 5-3 and Figure 5-4, the Northern Canal Waste Gatehouse has wooden sill which overhangs the Northern Canal, with a bottom elevation of approximately 91.3 ft NGVD29. The normal maximum operating elevation of the Northern Canal is 91.5 ft. Figure 5-3 and Figure 5-4 show that the canal water surface elevations for the study period occasionally exceeded the bottom sill elevation, thereby inundating the heavy timber bottom sill on the south side of the structure (Photo 5-6). The Northern sill of the Waste Gatehouse has also deteriorated, due to natural exposure to the nearby river and atmospheric conditions, as well as its proximity to the spillway immediately to the east. It is possible that splashing water from the adjacent spillway may have contributed to the deterioration of the eastern third of the northern sill timber. Repeated inundation and drying of the timber sill can be a contributing factor to deterioration. Other factors, including the age of the wooden timbers, general maintenance, weathering, and atmospheric conditions are also likely to have contributed to the deterioration of the southern sill, and the eastern portion of the northern sill. The age of the sills is not known, i.e., it is not known if the existing sills are the original timbers from the 1872 construction of the gatehouse.

*Photo 5-6. Northern Canal Waste Gatehouse underlying timber sill.*

The operation of the Northern Canal has caused periodic inundation of the sill at the Northern Canal Waste Gatehouse. This inundation may be one factor in the continued deterioration of the gatehouse's southern sill. Spray from the canal spillway may also be contributing to deterioration along the eastern end of the northern sill.

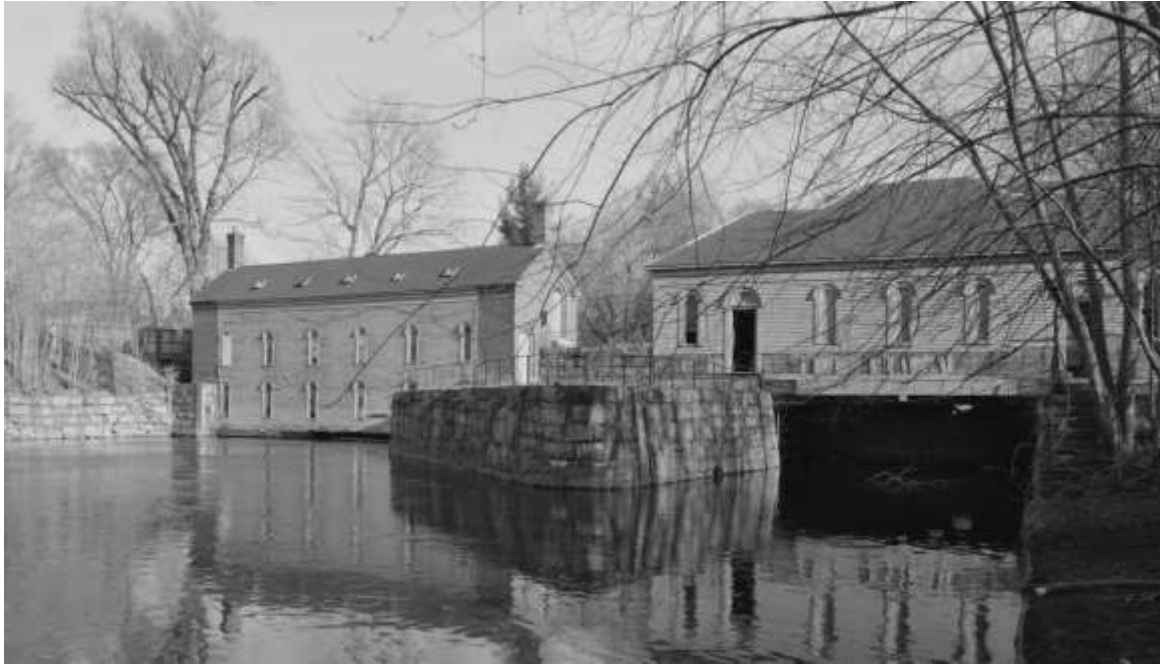
The Upper Pawtucket Canal branches off the Merrimack River a few hundred feet upstream of the Pawtucket Dam and feeds water into the downtown canal system via the Guard Lock and Gates Facility (“Guard Locks”). The facility consists of the following structures: 1) the Guard Gatehouse which houses 5 sluice gates to convey flow to the Lower Pawtucket Canal; 2) a 24 ft wide granite masonry Lock Canal with two pairs of wooden lock gates; 3) the timber and wood framed Lock House located above the upstream lock gate; 4) the Francis Gatehouse (or Great Gatehouse) timber and wood framed structure over the Lock Canal which houses the 25' high x 25' wide Francis (or Great) Gate. The Guard Gatehouse is separated from the Lock Canal and associated Lock House and Francis Gatehouse by an island with walls of granite, ledge, or concrete (Photo 5-7).

*Photo 5-7. 1976 - Guard Lock and Gates Facility viewed from upstream. The Guard Gatehouse is on the left and the Lock Canal and Lock House are on the right.*

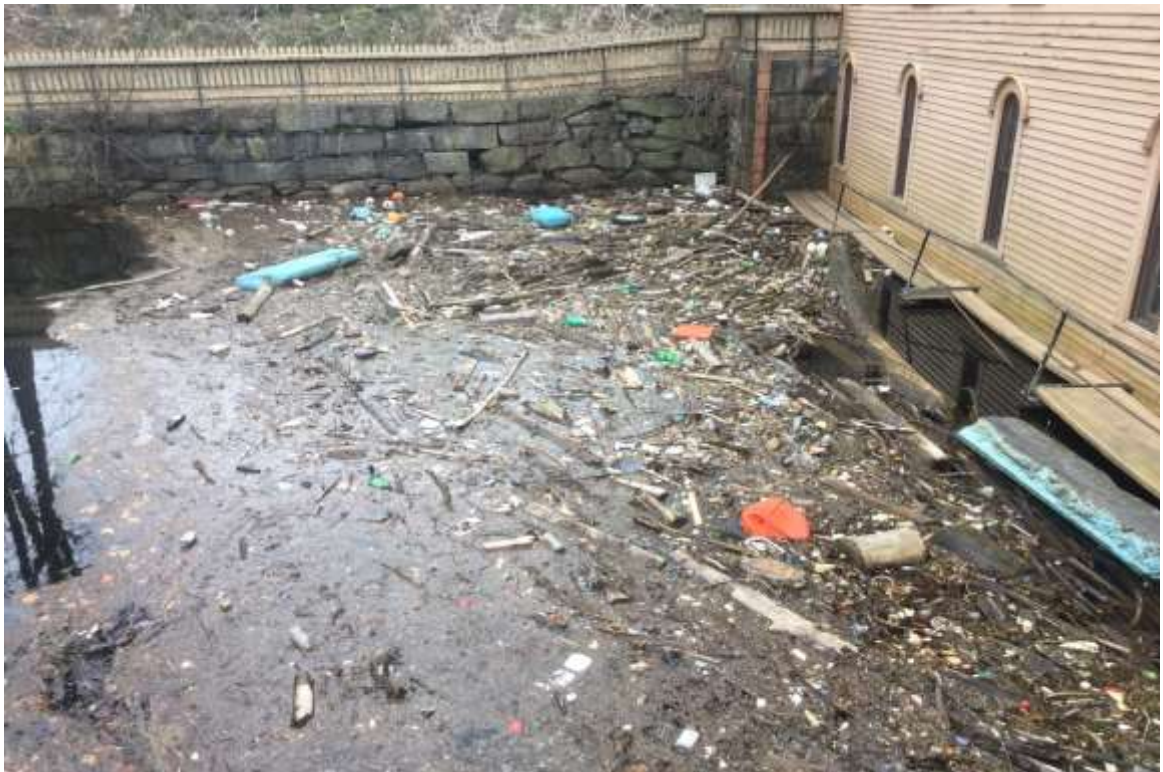
*Photo 5-8. 2019 - Guard Lock and Gate Facility.*

Water levels in the Upper Pawtucket Canal remained below the walkway at the base of the Guard Lock Gatehouse for the entire study (Figure 5-5 and Photo 5-8). The elevation of the walkway (92.45 ft), the clapboard siding (92.45 ft), and the bottom of the mid-level windows (94.08 ft) are all above the normal water level of the Upper Pawtucket Canal (Figure 5-5). Under normal operating conditions, these features are rarely inundated. However, high flow events that are beyond Boott's control can cause water levels to exceed normal operating conditions and may inundate the walkway, clapboard siding, and mid-level windows. As described above, the pneumatic crest gate control system maintains a constant upstream impoundment elevation under elevated flow conditions by automatically adjusting the height of the crest gate panels. The crest gates would be fully lowered at river flows of approximately 35,000 cfs, above which the impoundment and Upper Pawtucket Canal level would rise uncontrolled. Thus, river flows in excess of 35,000 cfs could cause the Upper Pawtucket Canal to inundate the wooden structural elements of the gatehouse; however, these conditions are outside of the ability of the project to control the impoundment water level and therefore not attributable to Project operations.

While normal Project operating conditions do not appear to be having a significant effect on the wooden structural elements of the gatehouse, the presence of waterborne trash and debris may adversely affect the gatehouse. Trash and debris accumulate upstream from Guard Lock Gatehouse, including large logs and timbers. While the magnitude of fluctuation in the Project headpond has been significantly reduced by the implementation of the pneumatic crest gates (see Figure 5-1), the Pawtucket Canal is subject to routine seasonal high flow events, which are more likely to convey trash and debris from upriver areas. While trash and debris that accumulate upstream from the gatehouse have the potential to damage exterior wooden elements and windows under such high flow conditions, natural high flow events and waterborne trash are not related to Project operations. Boott retains a crane service to remove the trash and debris from in front of the Pawtucket Gatehouse once or twice each year.
